ELLSWORTH SPRINGS CONDOMINIUMS

VANCOUVER, WASHINGTON

PROJECT SUMMARY

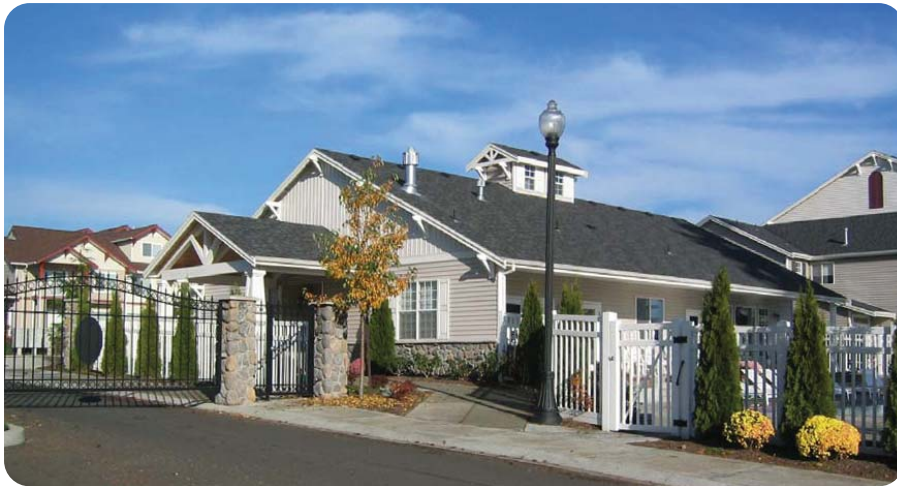
BEFORE

The site suffered from poor drainage with many areas of standing water surrounding the buildings and water laying in the subfloor crawlspaces. Many of the required structural hold-down connectors were improperly installed or not installed. The roof was leaking in many places, which required investigation.

Trinity | ERD did a unit by unit survey, and we are now removing siding and installing new structural hold-downs in several locations on each of the buildings. We are renailling the plywood sheathing to improve the wall diaphragms. We are removing the existing second and third floor patio deck walking surfaces and replacing them. The new patio deck walking surfaces will be properly integrated into the building envelope. We are improving patio deck drainage at the same time. Trinity | ERD and Porter are installing new site drainage to help with the standing water and improving the under floor venting and moisture barriers to deal with the standing water in the crawlspaces. We are walking the roofs and repairing hips, ridges, broken shingles, wall to roof transitions, and gutters and downspouts. We are improving attic ventilation and confirming that fire separation walls have been properly completed.
