## QUEEN'S MARKETPLACE

BIG ISLAND, HAWAII

### PROJECT SUMMARY

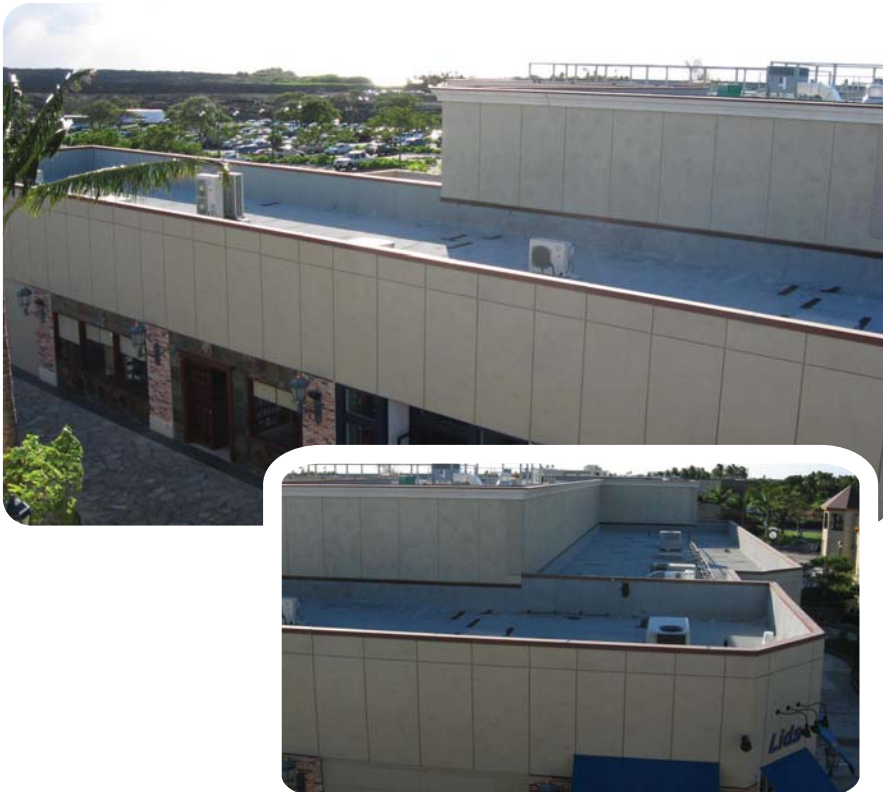
Queen's Marketplace is a 10-building outdoor mall on the Big Island of Hawaii. Queen's Marketplace had a roofing system improperly installed by a roofing sub-contractor. The roofing system manufacturer was unwilling to provide a warranty until the roof was replaced.

Our design team developed a Scope of Repair to address the existing installation issues to create a secondary redundant layer. A new reinforced liquid system with granule surfacing was designed to create the primary waterproofing layer.

We were onsite to provide construction supervision every day for over two months to ensure proper adherence to repair details to ensure the secondary layer would perform. Conducted EFVM (Electric Field Vector Mapping) Moisture Testing to confirm the base layer was watertight. The roofing manufacturer agreed to issue a fifteen year warranty for the installation with a commencement date of original completion.
