## PRESCOTT CONDOMINIUMS

PORTLAND, OREGON

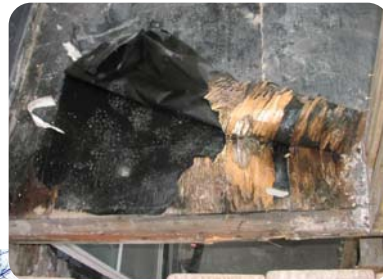
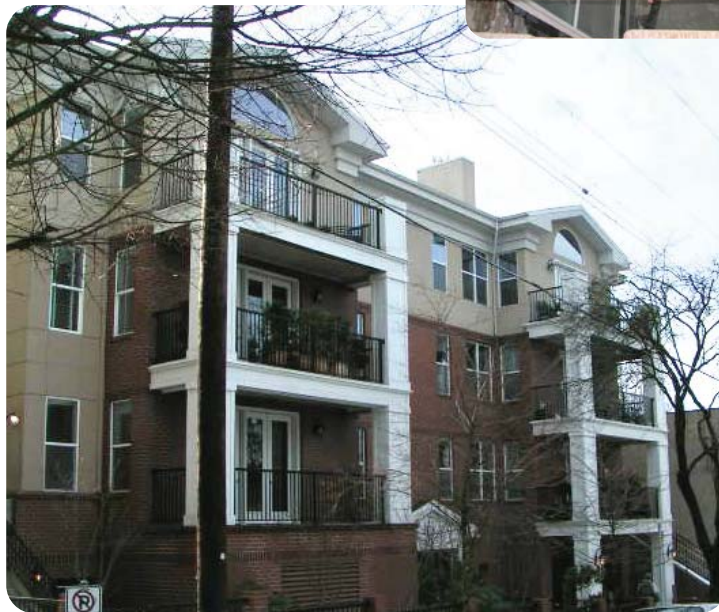
BEFORE

Shortly after the Prescott condominiums were occupied, problems with water infiltration into the exterior building envelope were observed. The original windows system installed did not have the City mandated sound rating to minimize the traffic noise from 23rd Ave. The structure was built on the property line limiting areas of drainage from the plaza decks that could not effectively drain.

Trinity|ERD identified a window system that would fit in the existing openings in the original configurations and would meet the city-mandated sound rating. A new drainage system was designed to capture water into internal drains and direct it to the storm sewers.
